**Report on the Condition and Conservation evaluation visit to
Kremenets and Vishnevets District Jewish Cemeteries,
Western Ukraine**

21st - 25th April 2007

**On Behalf of The Kremenets-District Jewish Cemeteries
Restoration Project**

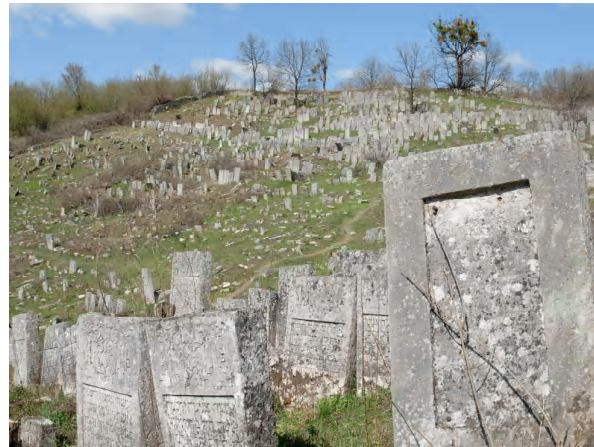
Kremenets cemetery is by far the largest of the sites visited, containing in excess of eight thousand graves. Located on a fairly steep hillside the cemetery has obviously been neglected for a substantial period. Recently the area has been cleared of trees and undergrowth to reveal the full extent of the cemetery and the extent of the boundary wall.

General view of Kremenets cemetery

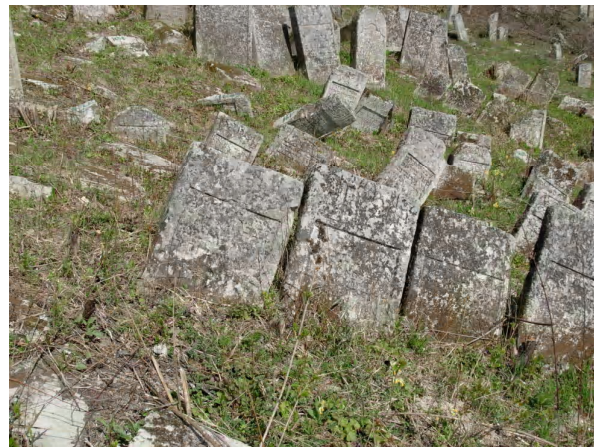
With the exception of a very limited number of high status burials the graves appear to be shallow cut and don't appear to utilise sarcophagi or any other form of sub-surface structure. This has led to subsidence in many areas of the cemetery, due to either settling of headstones toward newer grave cuts or gradual erosion of the soil down the hillside.

Subsiding graves on higher slope

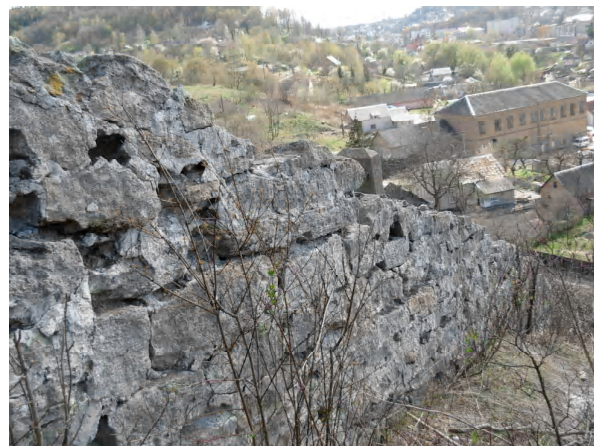
The perimeter wall of the cemetery has also suffered a large degree of material loss and it would not be unreasonable to assume that material from the cemetery has been taken for use in new construction in the surrounding neighbourhood. A survey of local building would quickly substantiate this hypothesis.

Most intact section of the parameter wall

Access to the site needs to be controlled and visitors encouraged to walk on predetermined routes through the cemetery, that give good access while steering visitors away from the more vulnerable areas of the site. A fence should be erected around the parameter of the site to limit access to predetermined entrances, where information in the form of presentation boards should inform the visitor on the history of the site and the restoration work being undertaken and explain the need to limit access to certain areas. As in most areas of the site access is extremely difficult due to the number and density of the graves, the original parameter wall should not at this stage be rebuilt, but enclosed by a temporary fence. In this way access by a conservation team to many restricted areas of the site can be simply achieved by removing sections of the fence. The wall can be rebuilt after the graves have been treated and the need for access is reduced.

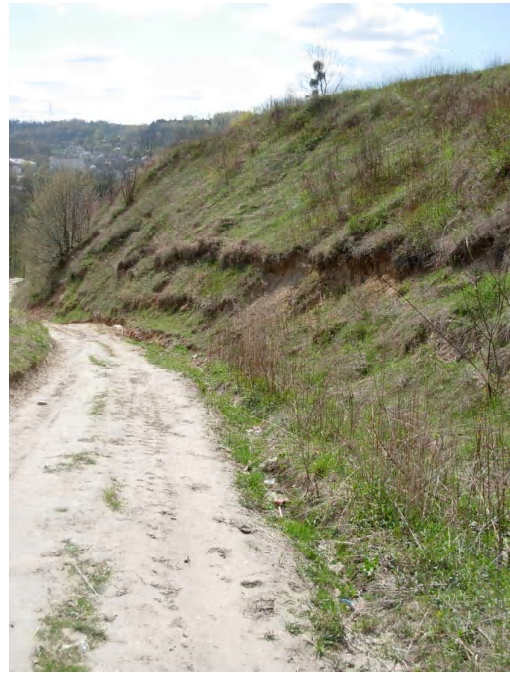
The most obvious sign of active deterioration at the site is on the bank adjacent to the road below the site. Here there is evidence of continual erosion of the slope and the presence of grave stone fragments at the base of the slope would suggest that erosion has now progressed to a point where it is encroaching within the boundary of the cemetery.

Actively eroding slope below cemetery

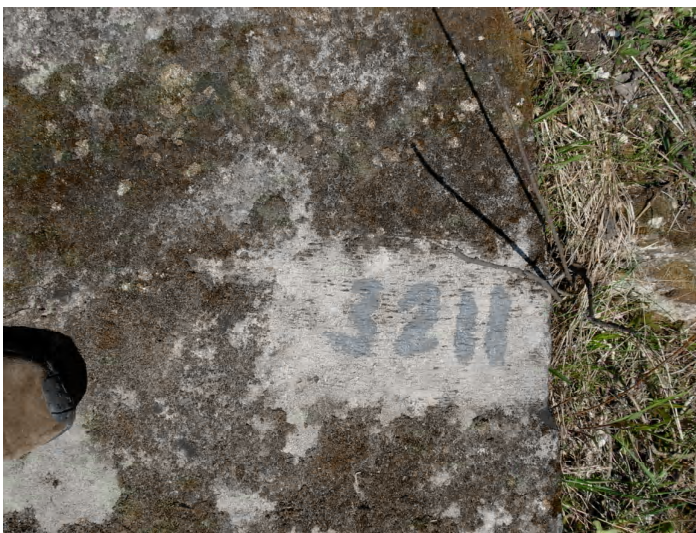
As vegetation was cleared from the site the exposed headstones were recorded and numbered. Numbering was achieved by cleaning the surface of the stone and applying a painted number. Both the cleaning process, which appears to have been achieved by wire brushing the surface and the application of a paint layer that will kill the lichen, may leave irreversible discolouration and “shadowing” when the entire surface is subsequently cleaned.

The method of numbering of stones needs to be revised. The current method of painting numbers is both unsightly and short-term. With excess of eight thousand graves, it will be years before some headstones are cleaned and/or reset in position. In the author's experience, painted numbers can last for as short as one winter, especially if they are painted on top of a lichen layer that will die and detach from the stone surface taking the paint with it. Using the current methodology it will be necessary to check every number, every year. A system of much smaller, more permanent numbering should be devised, maybe pressed metal tags firmly adhered to the stones with a reversible adhesive. The physical labels should also be backed up by accurate maps, physical, digital or both, so that if a tag or number is lost or removed, the identity of the stone can be determined easily and accurately.

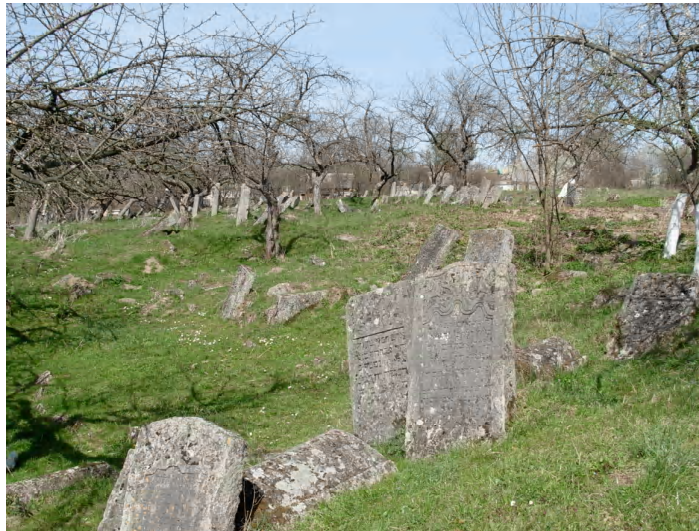
Vishnevets Cemetery

The graves and headstones are on the whole of a higher status than those of Kremenets, with relief cut inscriptions as opposed to the incised inscriptions and a much higher standard of ornamentation. More crucially the graves utilise sarcophagi set into the slope of the hill. The use of sarcophagi means that determining the original position of the grave is far easier than at Kremenets, resulting in the need for far less excavation than would be required at Kremenets.

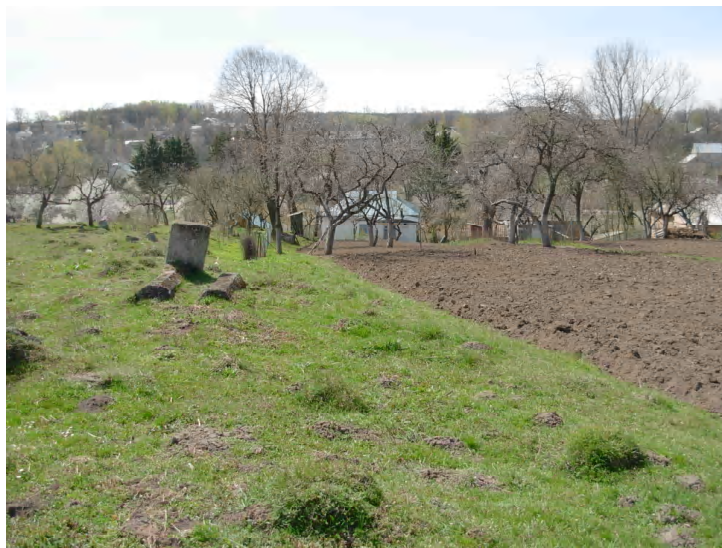
Probably the greatest threat to the cemetery is from encroachment from the surrounding human habitation. The cemetery is directly adjacent to houses and cultivated land. At the top of the site is a ploughed area. The cultivate land does not appear to encroach on the cemetery, but it is very, very close.

Ploughed area adjacent to the cemetery

The most important short term intervention at Vishnevets is the establishing and protection of the site boundaries with temporary fencing and removal of the rubbish heaps and associated trees and undergrowth. As with Kremenets the erection of temporary fencing should be accompanied by an information initiative to heighten awareness of the significance of the cemetery. Vishnevets

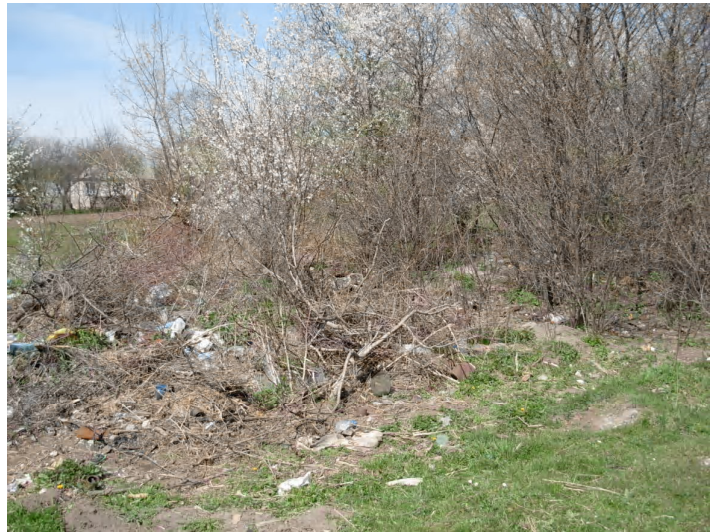
Another result of the closeness of habitation is the dumping of rubbish on the site. Two substantial mounds have evolved and in these areas trees and undergrowth are becoming established.

Rubbish dumped on the cemetery site.

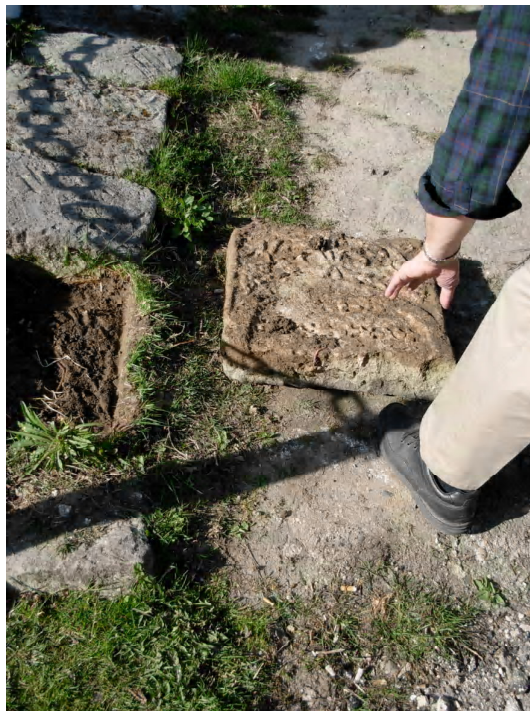
Although the history of how these stones ended up at this location is extremely unpalatable, it is the fact that these stones, having been laid face down and subsequently buried, have been well protected from destructive elements. The inscriptions on these stone were some of the best preserved examples viewed during the visit.

It has been proposed that the stones be removed and returned to the cemetery. While this is an obvious reaction, it cannot be stressed enough that unless very good storage facilities are available, removal could lead to accelerate deterioration of the stones. A project of recovery of these stones should be undertaken only as part of a much broader integrated conservation and management plan devised to encompass all the sites.
